Manhole Inspection Summary

Manhole # S2311_006MH

Insp Date: **11/21/08 10:46 AM**

Location Address: **2815 Ganley Dr.** Cross Street: **Northshire Rd.**

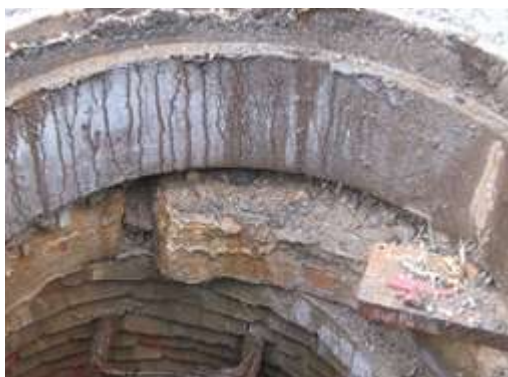
Defect 6

Condition: ☐ Sound ☒ **Cracked** ☐ Root Intrusion ☒ **Loose Brick** ☒ **Deteriorated**

missing mortar and brick at chimney

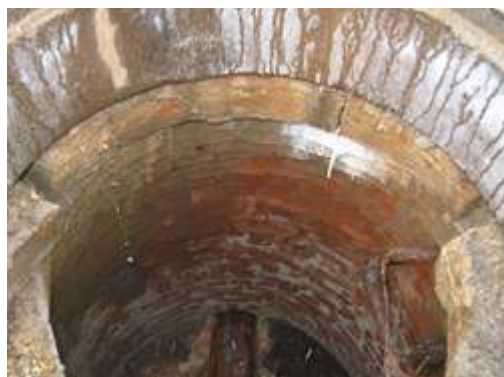
Defect 4

Infiltration: ☐ None ☒ **Joint** ☐ Cracks ☒ **Mortar** ☐ Roots ☐ Wall

Infiltration: ☐ None ☐ Joint ☐ Cracks ☒ **Mortar** ☐ Roots ☒ **Wall**

chimney and corbel infiltration

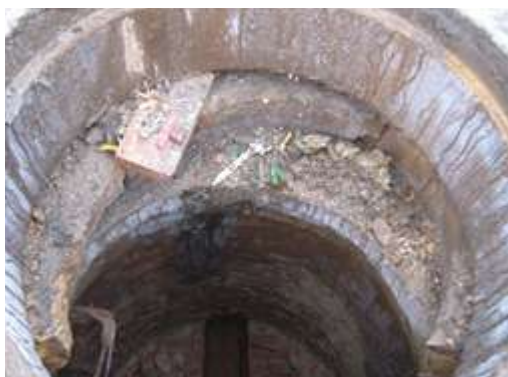
Defect 3

deteriorated chimney with infiltration

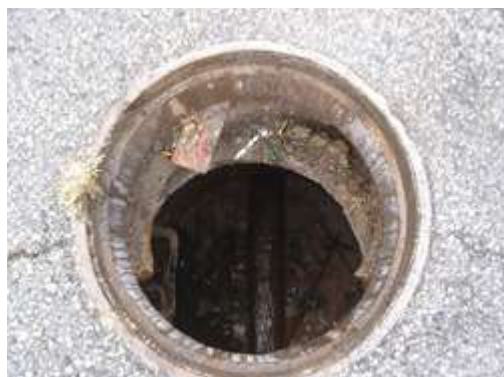
Defect 2

Frame Offset: **5** (in.) Condition: ☒ Sound ☐ Cracked ☐ Leaks

frame offset

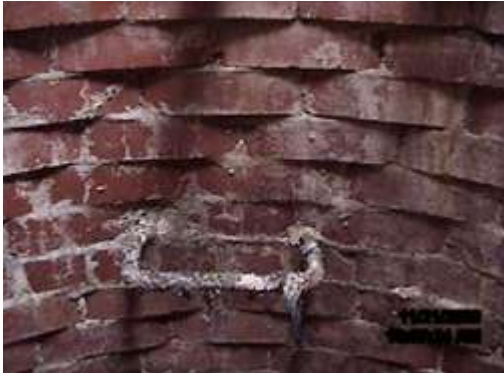
Defect 1

Steps Count: **4** Missing: **0** ☒ **Corroded**

Surcharge ☒ **Evidence Of Surcharge** Depth: **1.5** (ft.) ☐ Active Surcharge Present

surcharge on corroded step

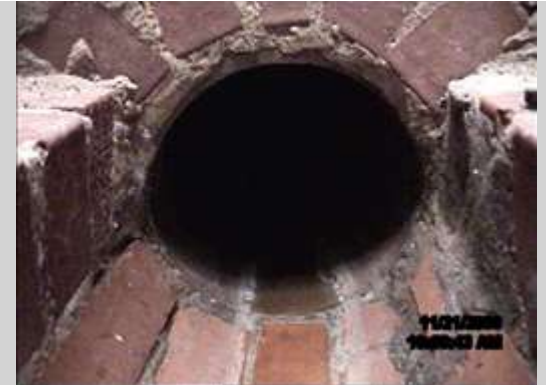
12 O'Clock Outflow

Pipe Height: **8.4** (in.) Rod and Bar (Angled)
Pipe Material: **Clay** ☐ Pipe Lined
Invert Depth: **8.31** (ft.) Flow Characteristics: **None**
Deposits: ☒ None ☐ Mud ☐ Sludge ☐ Debris ☐ Grease
Silt Depth: **0** (in.) Deposits Extent:
Infiltration: **None** Pipe Seal Cond: **Sound**

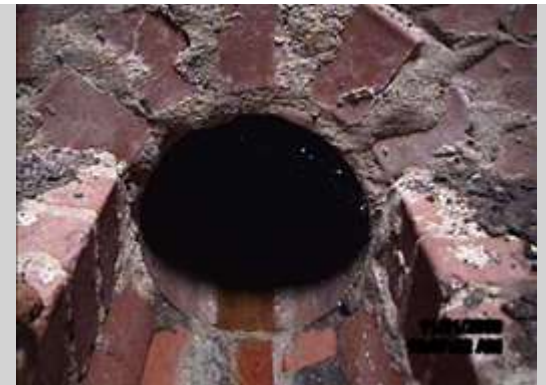
6 O'Clock Inflow

Pipe Height: **8.4** (in.) Rod and Bar (Angled)
Pipe Material: **Clay** ☐ Pipe Lined
Invert Depth: **8.09** (ft.) Flow Characteristics: **None**
Deposits: ☒ None ☐ Mud ☐ Sludge ☐ Debris ☐ Grease
Silt Depth: **0** (in.) Deposits Extent:
Infiltration: **None** Pipe Seal Cond: **Sound**
